Appendix E – Crash Data

**SUBJECT:** SAFETY SCREENING

Goodell Street, S H. #60-2

Route NY 33 City of Buffalo Erie County PIN 5814.66

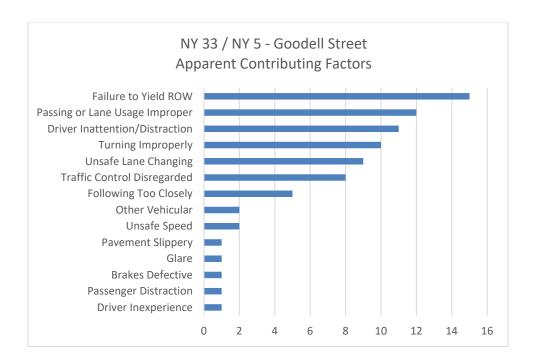
### 8. Apparent Contributing Factors:

The prevalent apparent contributing factors listed by police on the MV -104 Crash Reports are as follows:
